Mcdonnell Road, Arrowtown
Landuse Change
Preliminary Site Investigation

Arrowtown Lifestyle Retirement Village

October 2015

**Arrowtown Lifestyle Retirement Village
Landuse Change
Preliminary Site Investigation**

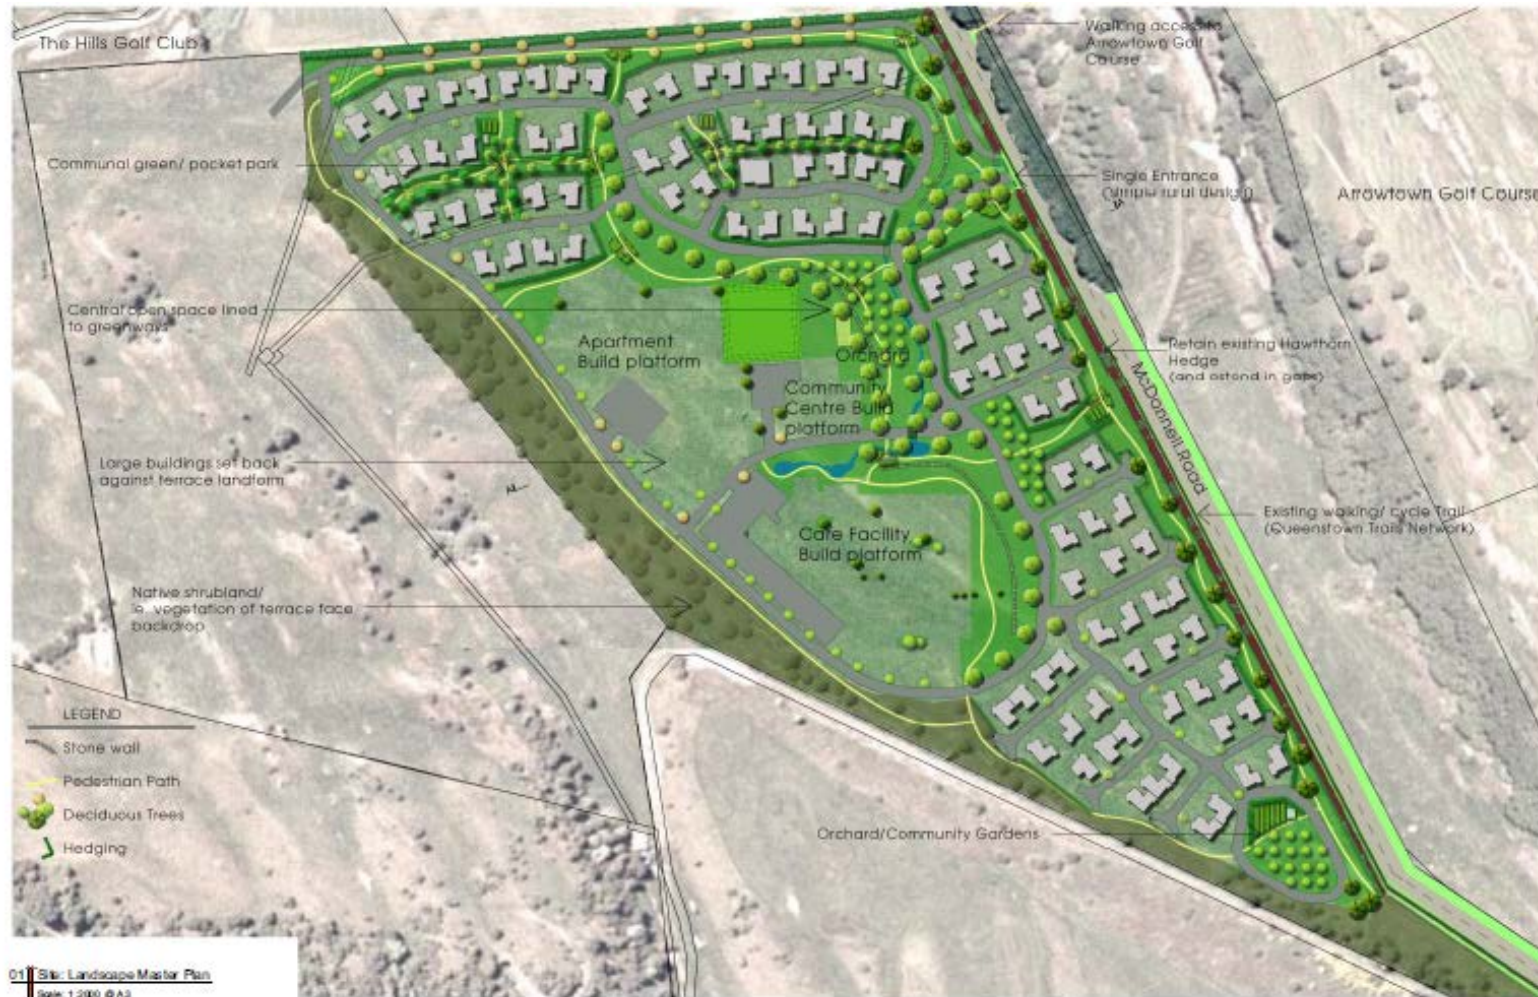
Figure 2: Proposed Lifestyle Retirement Village Plan (provided by, Momentum Projects Ltd)

The Arrowtown Lifestyle Retirement Village proposal comprises an area of approximately 12 ha within Lot 5 DP 26714. The proposed development concept plan is shown in Figure 2.

Arrowtown Retirement Village | Plan: Site Layout

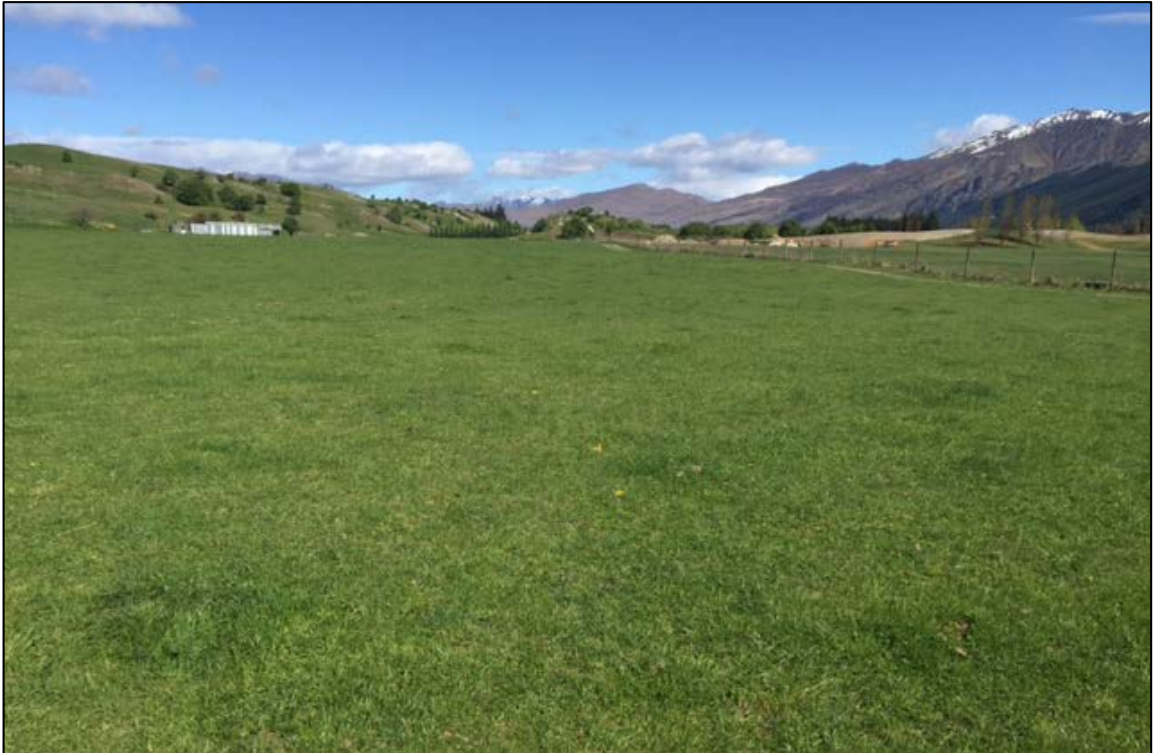
A grass airstrip runs in a northwest orientation along the centre of the site (see Plate 1). At the north-western end there is a small aircraft hanger building and associated sheds (see Plate 2). The hanger and surrounding sheds were inspected. There was no chemical or fuel storage, no odours and no evidence of spills.

Plate 1: Looking west along airstrip. Hanger in background.

DCG recommend further soil investigation in and around the hanger and associated area of the airstrip to assess possible soil contamination from heavy metals and pesticides that may have resulted from handling of fertilisers.

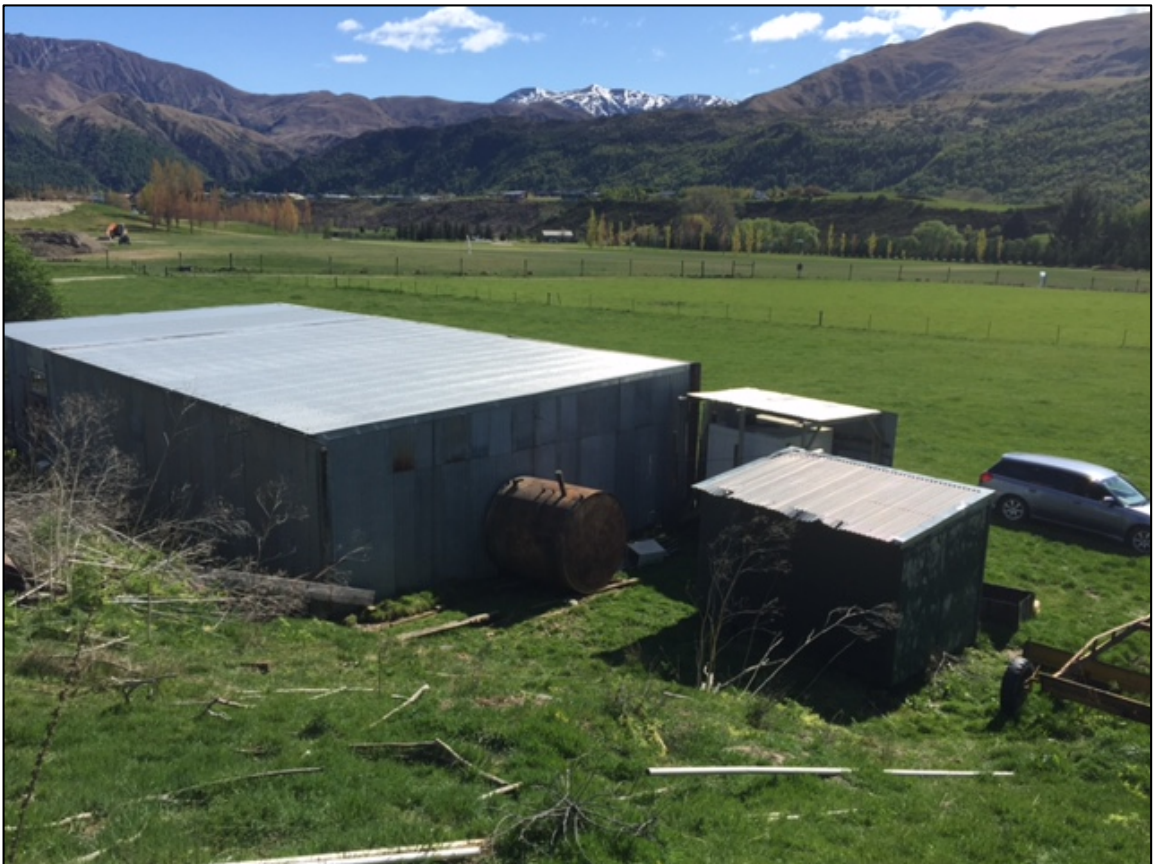
Plate 2: Behind hanger, looking north.

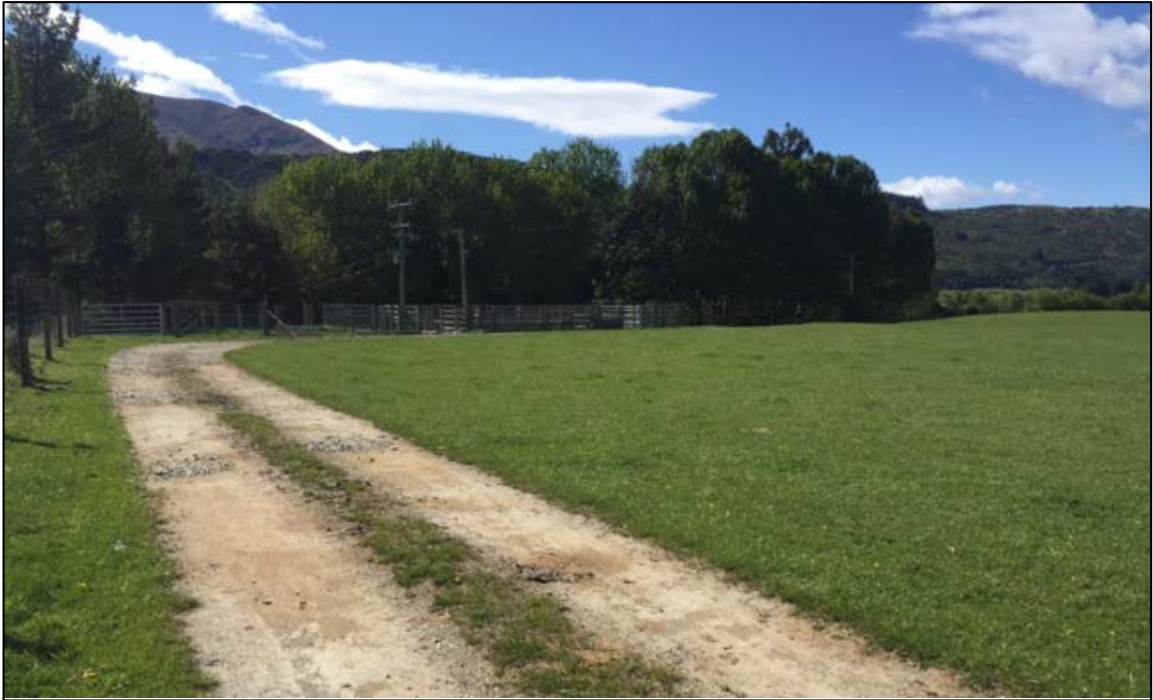
In the northwest and the centre north of the site cattle are grazed within paddocks fenced from the airstrip. A track runs along the northern end of the site, allowing access through gates (see Plate 3). In the north eastern corner of the site, there are yards beside McDonnell road (see Plate 3 and 4). The paddocks and yards were well maintained and there was no rubbish noted during the site visit.

Plate 3: Northern track, pasture and stock yards.

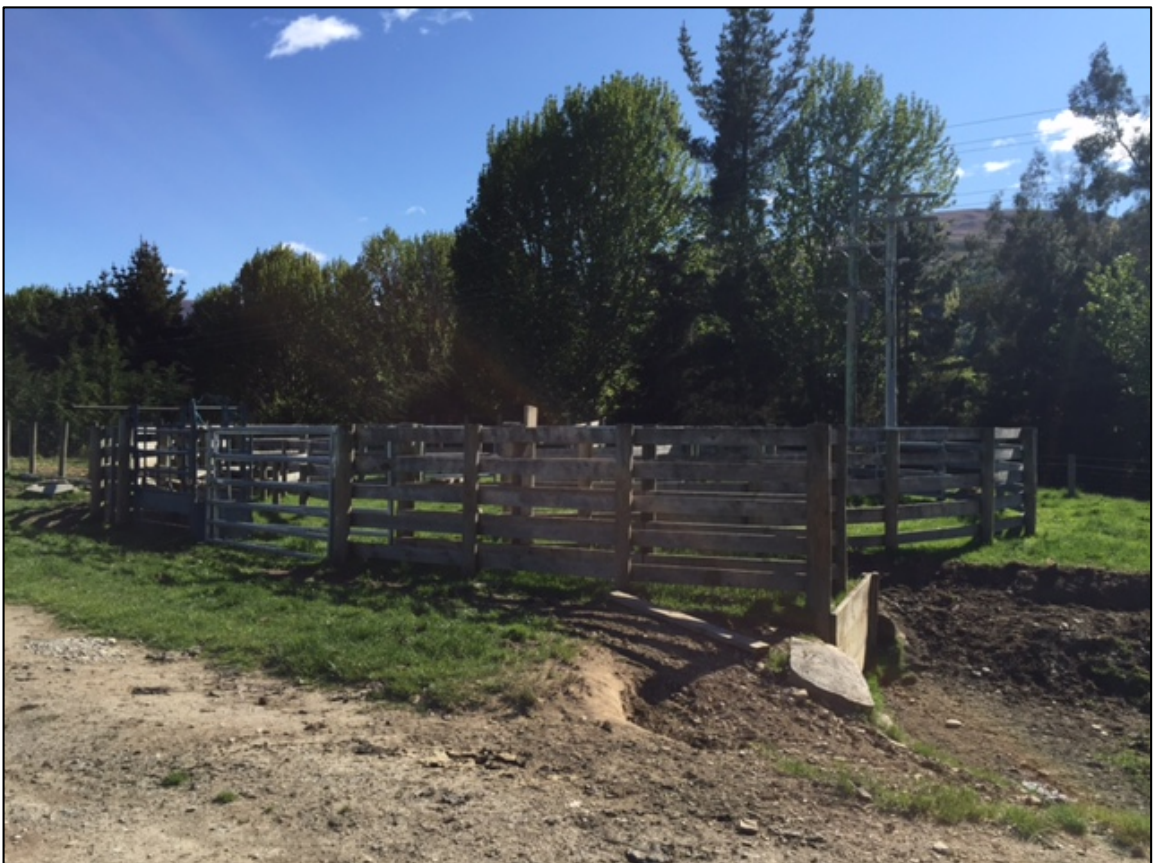
Plate 4: Cattle yards and powerlines.

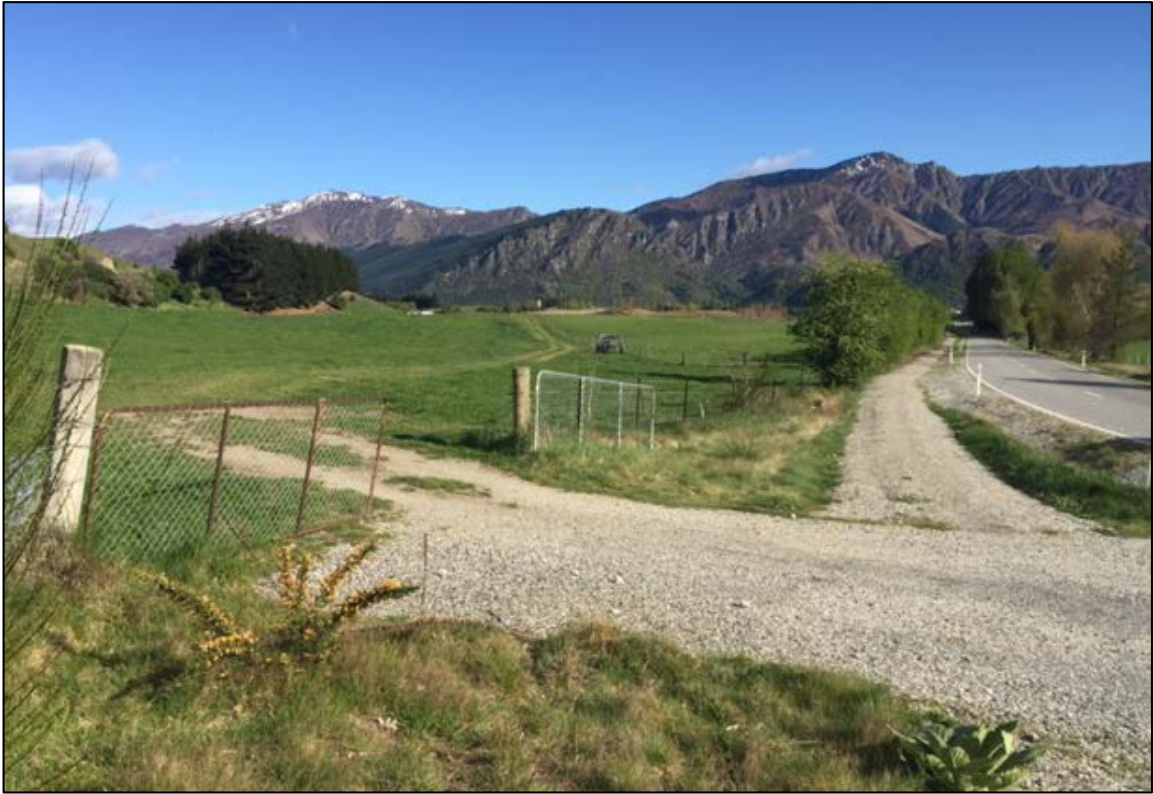
The site is bordered to the east by McDonnell Road. Beyond McDonnell Road there is rural residential land and a south-easterly flowing ephemeral drainage line (see Figure 4). Between the property fence and McDonnell Road there is a powerline (see Plate 4 and 5).

Plate 5: Southern access gate, McDonnell Road.

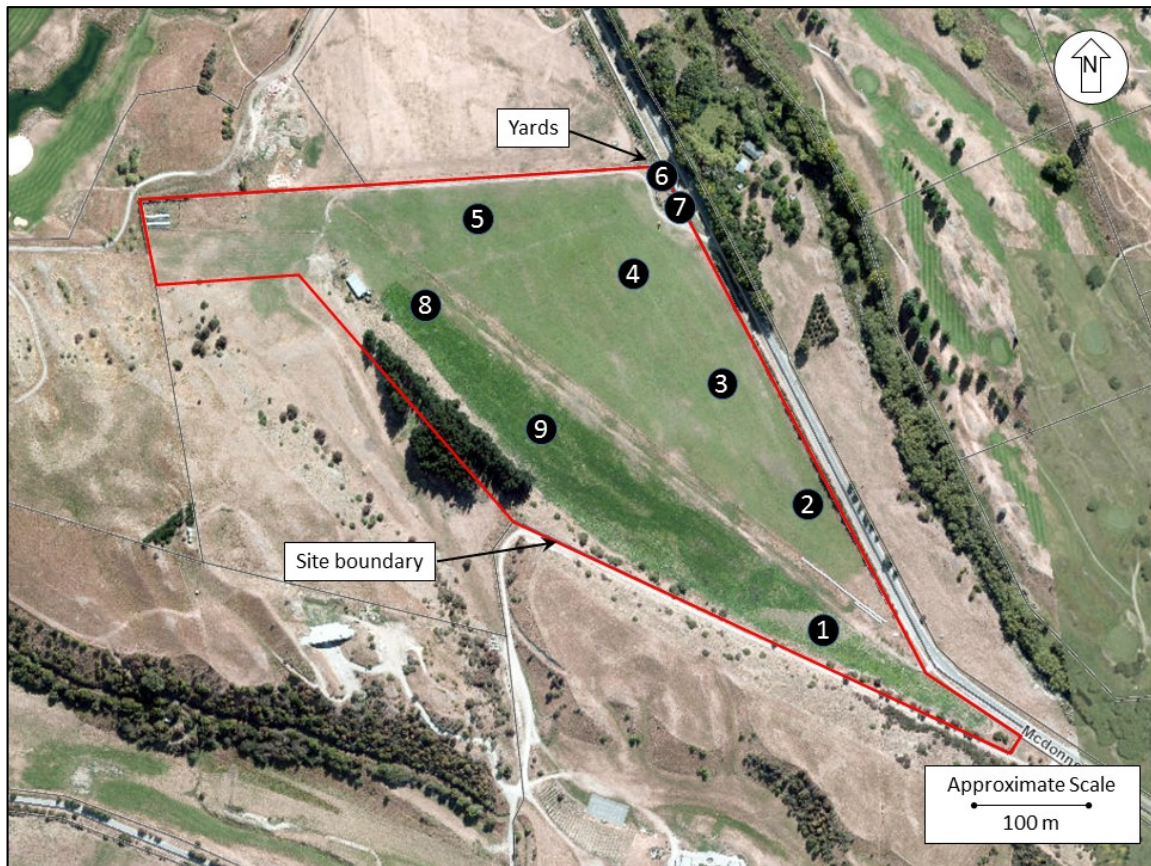
Figure 6: Sampling locations

The sampling rationale was designed to address possible broad acre applications to soil. Nine surface samples (0-0.1 m) were collected using an approximate grid of approximately 130 m. Sample locations are shown in Figure 6.
